AIRCRAFT ACCIDENT REPORT

ASSOC/2013/10/03/F

Accident Investigation Bureau

Report on the Accident involving Associated Airlines Limited Embraer 120 ER aircraft with registration 5N-BJY, which occurred at Murtala Muhammed Airport, Lagos on 3rd October, 2013.

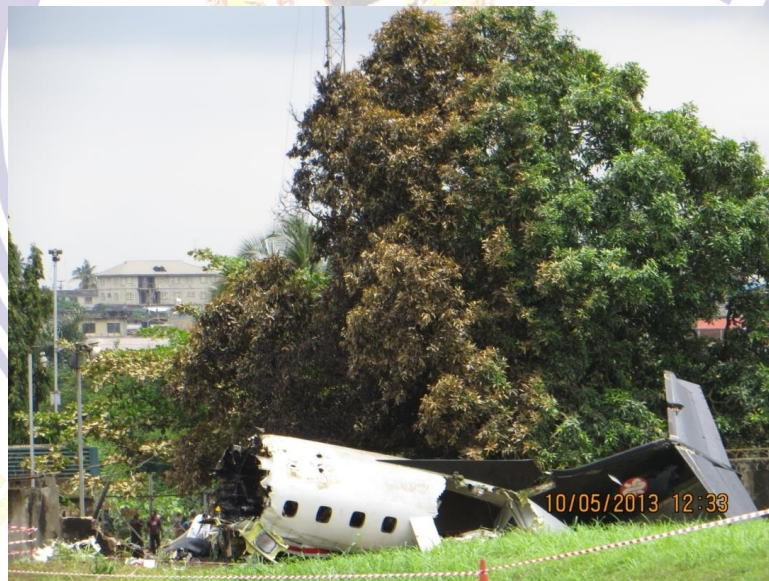
Figure 4: A view of the rear fuselage

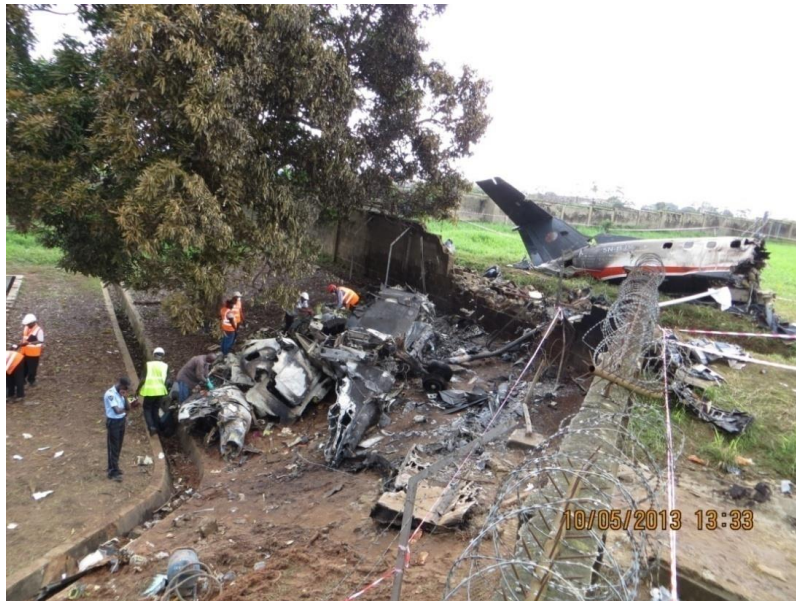
Figure 5: The Aircraft wreckage

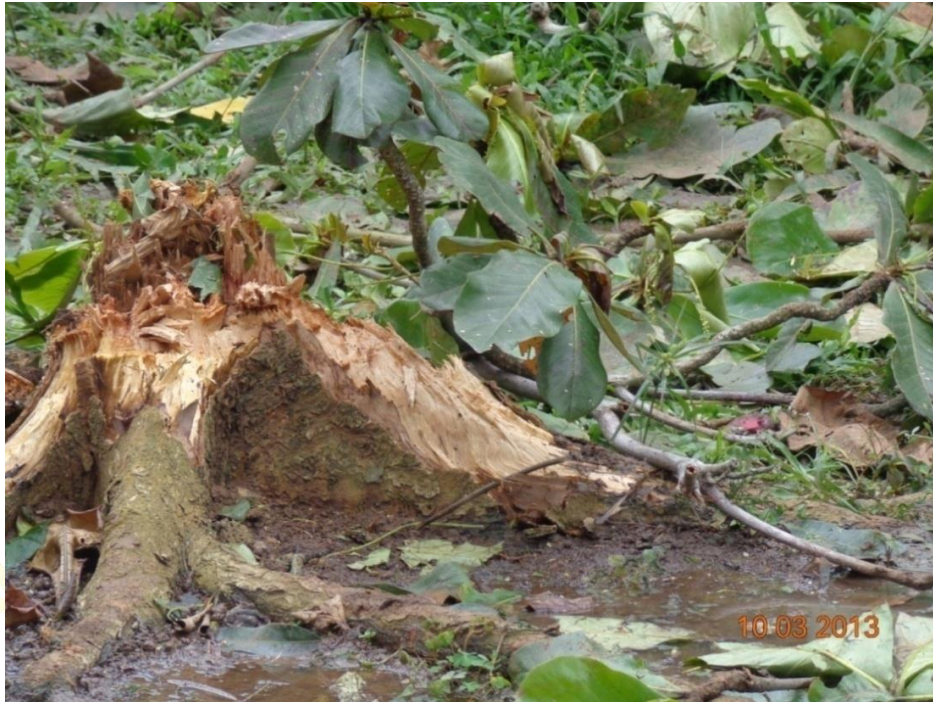
Figure 8: Another Tree felled by the Impact

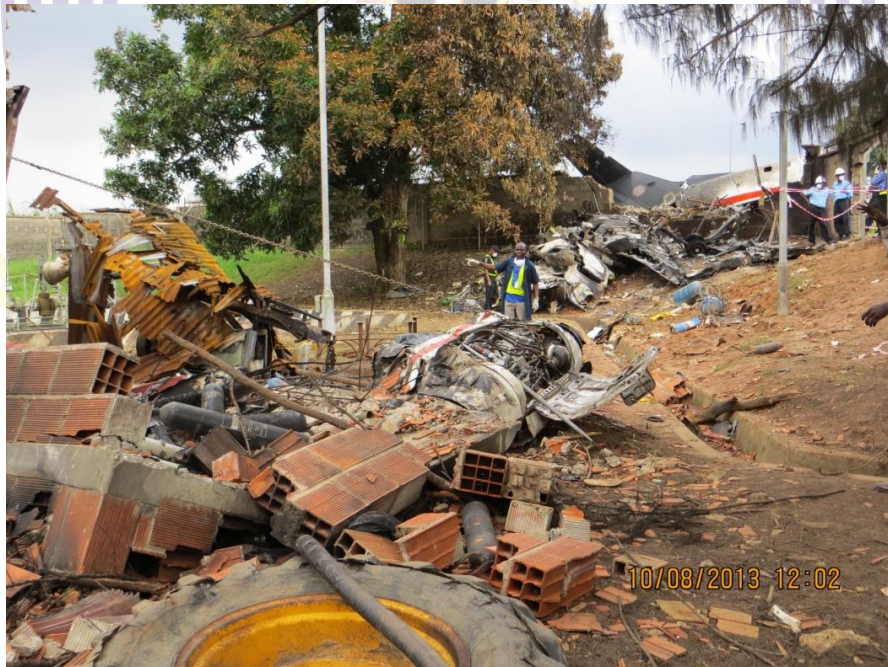
Figure 9: The Aircraft Engine and Generator Room destroyed by post impact fire

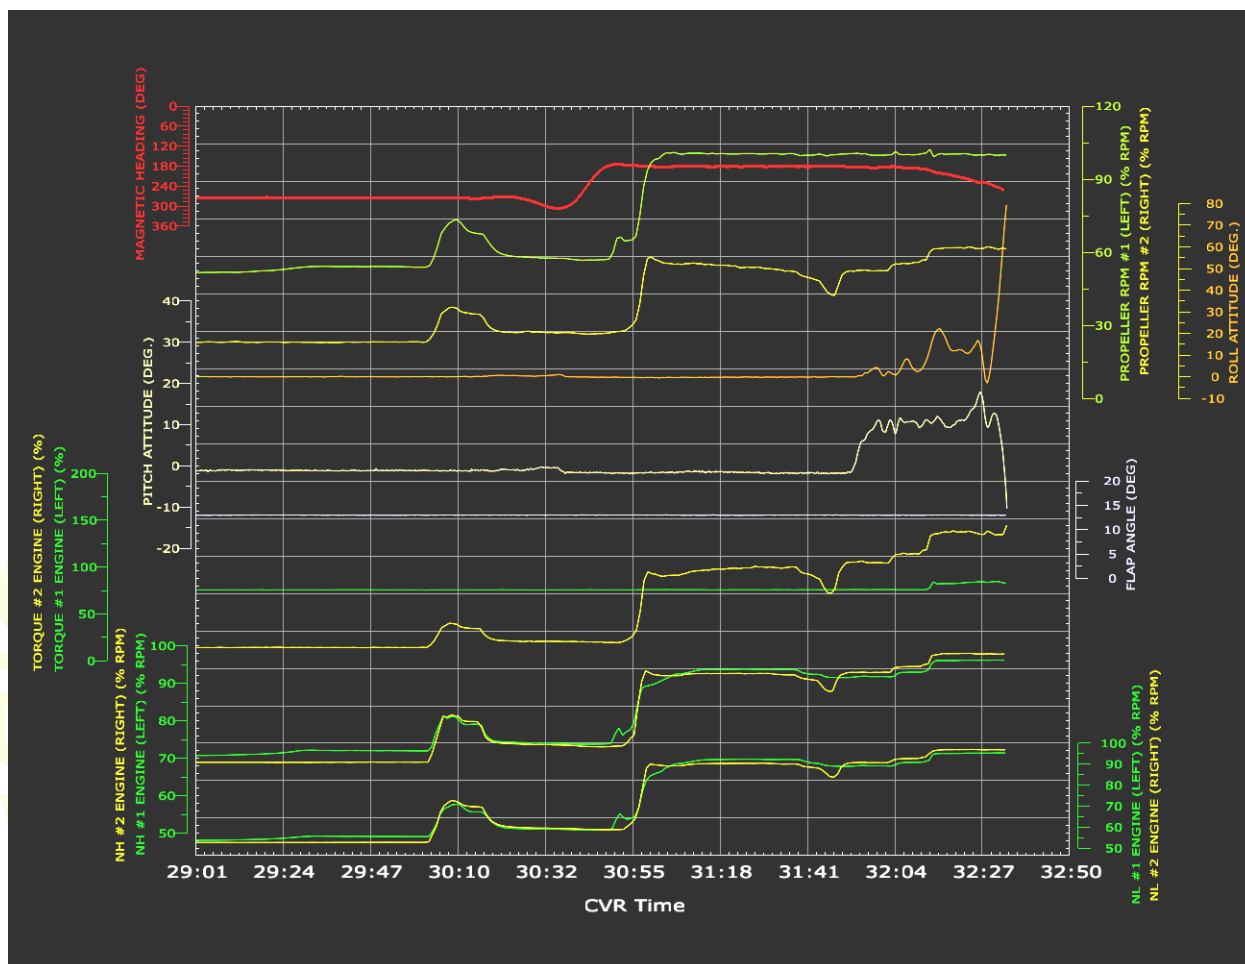
Figure 17: FDR Traces

From Figure 17, the aircraft was rotated to approximately 13° pitch attitude, attained maximum altitude of 118 feet above the ground where it stalled and impacted the ground at an attitude of 80° bank to the right and a nose-down pitch of -10°.

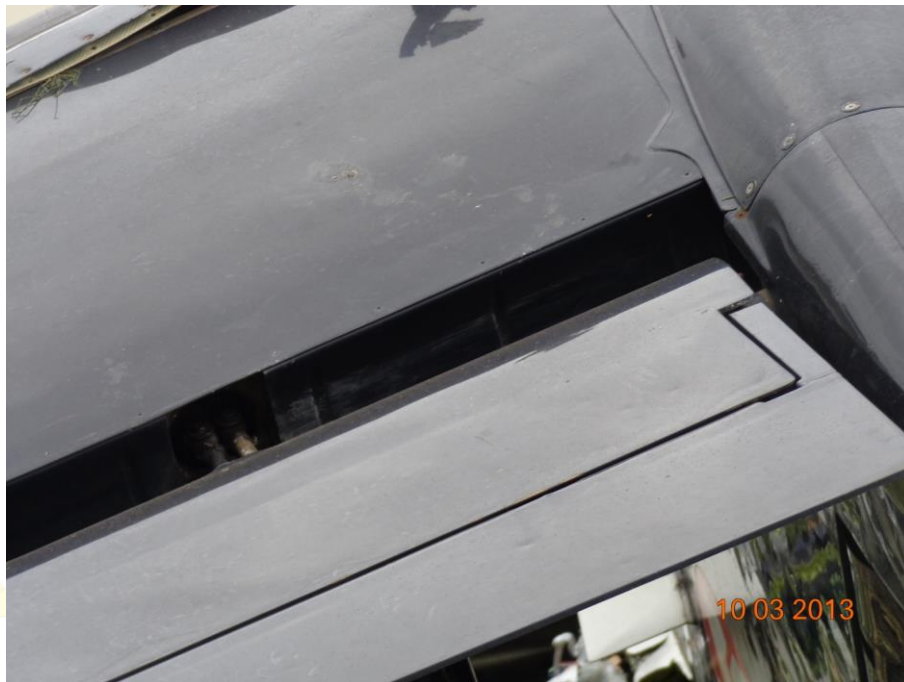
The trailing edge flap surface was extended to about 15°. The right generator switch, the bleed air switch and most of the right engine cockpit switches were in the "OFF" positions. The right engine fire handle was pulled and activated.

Figure 20: Trailing Edge Flap indicating selected Flaps

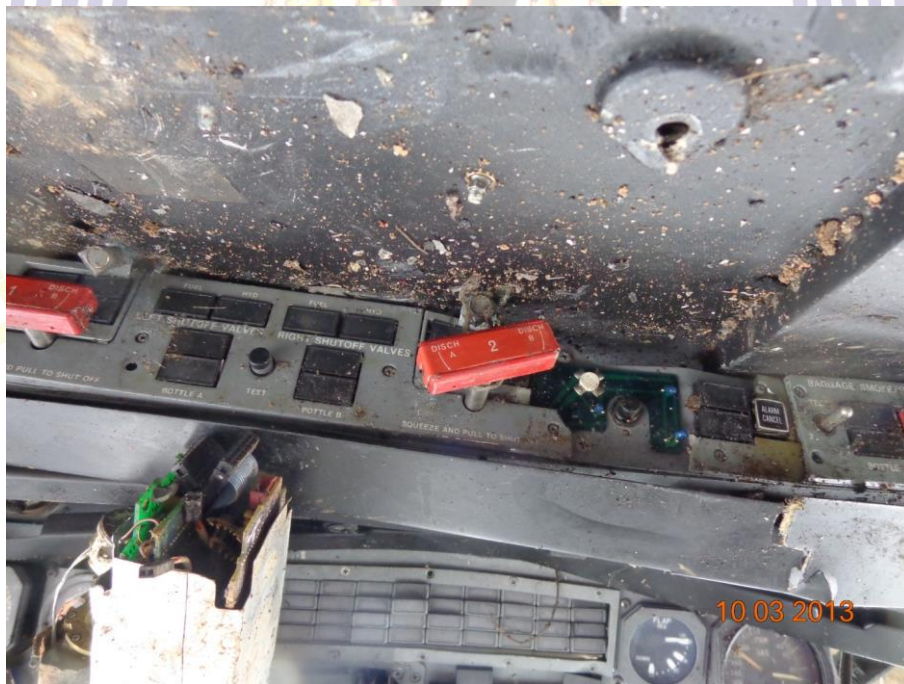
Figure 21: The No. 2 Fire Handle Pulled and Activated

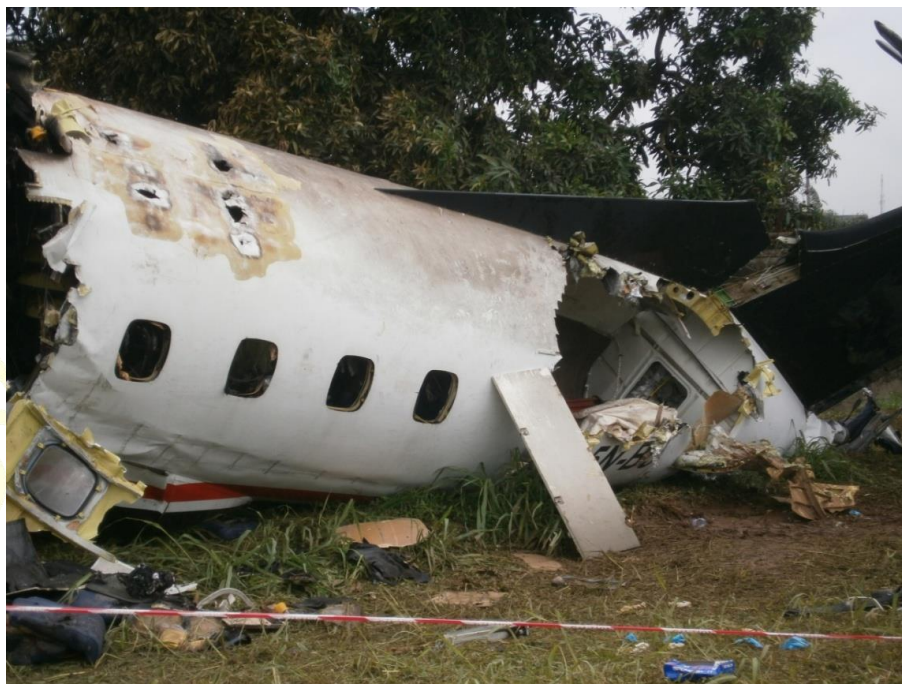
The passengers seated at the rear section of the aircraft survived because there was liveable volume, effective restraint system, and swift rescue operations.

Figure 22: The Aft Section of the Fuselage

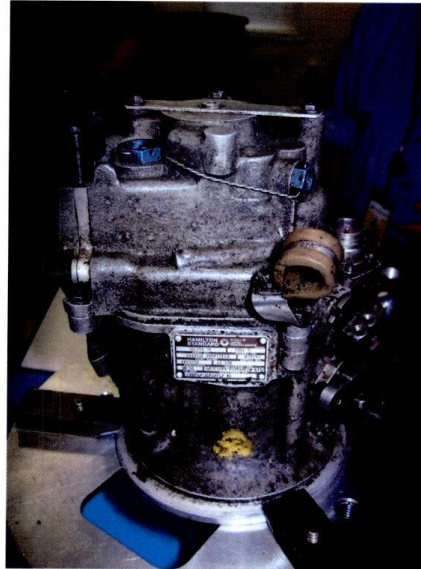
The propeller control was received without the adapter housing, but was otherwise complete (Figure 1). The unit was dirty and suffered an impact which damaged the main housing adjacent the beta light connector (Figure 2). This damage prevented testing the PCU on a hydraulic test stand due to the possibility of metal contamination of the test stand. The visual inspection also revealed a bent starboard condition lever (Figure 3).

Figure 1. Propeller Control 871213 in as received condition.

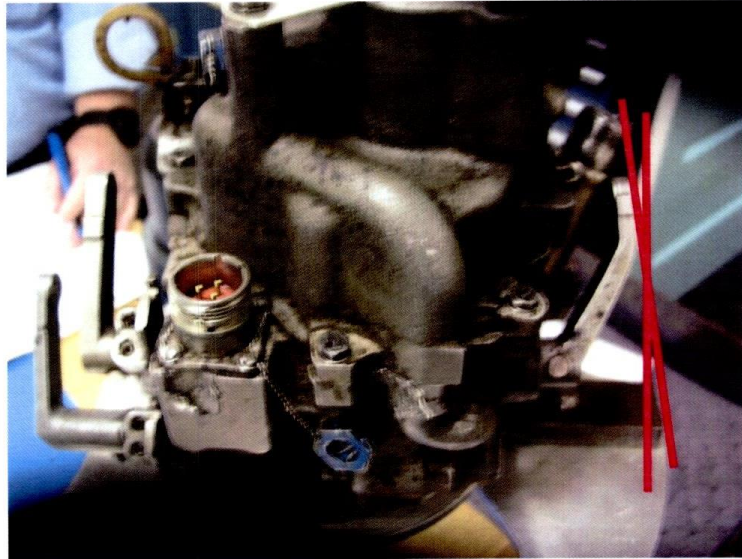
Figure 3. Bent Power Lever.

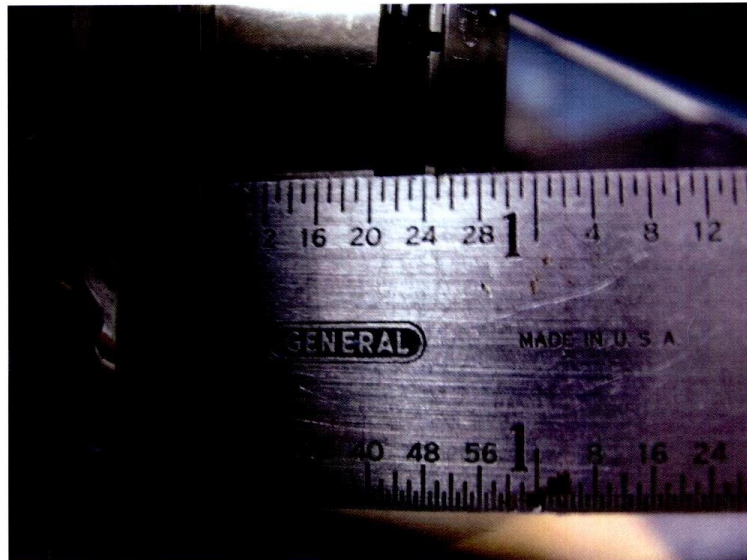
The ballscrew was measured to correlate the position to a blade angle (Figure 4). This position equals approximately 70.5 degrees β 42 (Feather = 79.2 degrees β 42).

Figure 4. Ballscrew position.

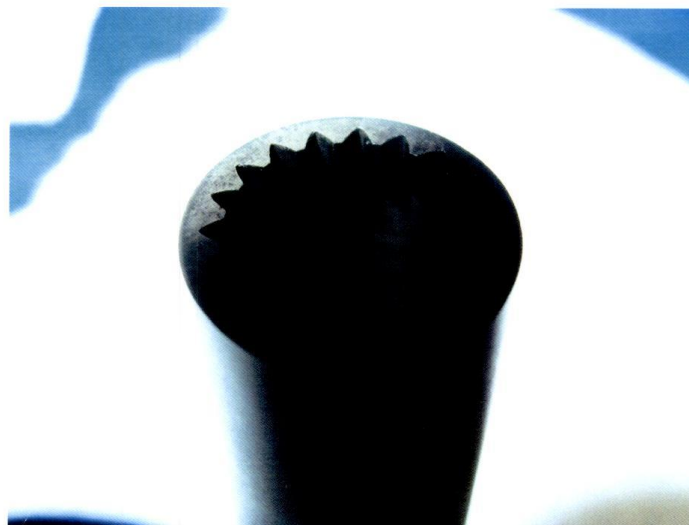
The primary quill (Figure 5) was removed to enable an examination of the quill and ballscrew splines. No measureable wear was noted on the internal primary quill splines (Figure 6) and external primary quill splines (Figure 7). The ballscrew internal splines were in good condition and no measureable wear was observed (Figure 8).

Figure 6. Internal Primary Quill Splines.

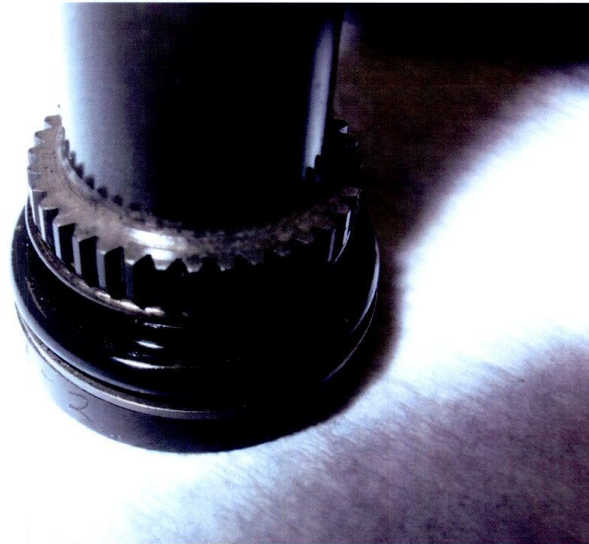
Figure 7. Primary Quill External Splines

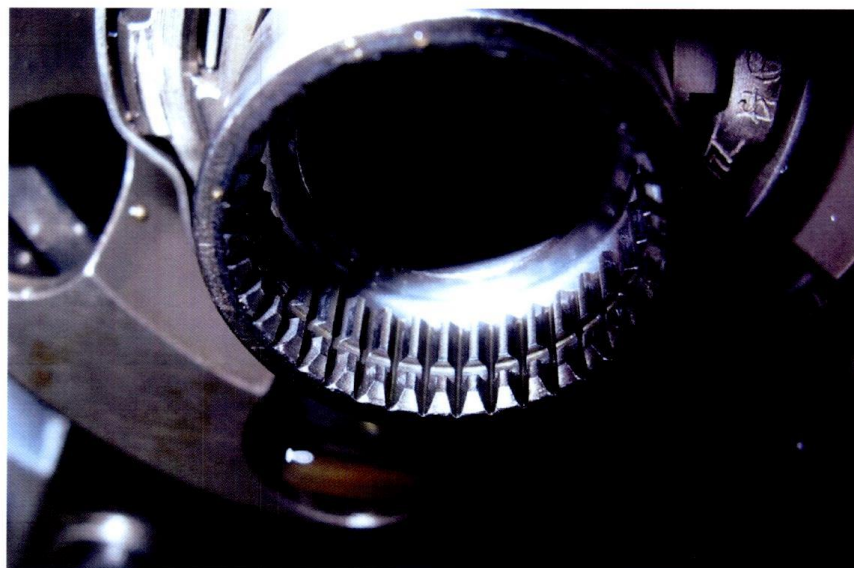
Figure 8. Ball screw Internal Splines

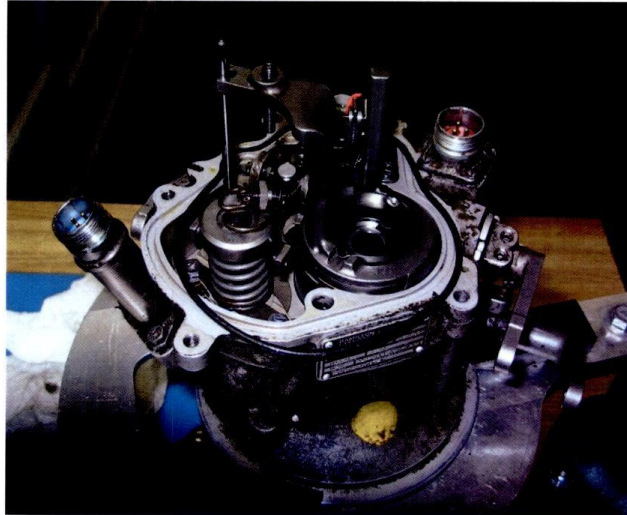
The upper housing was removed to gain access to the interior of the PCU (Figure 9). No visible damage was noted. The governor lockout valve was confirmed to be the latest configuration, with the locking pin present (Figure 10). The presence of the secondary drive quill and beta light functionality (on/off only) were also verified.

Figure 9. PCU Upper Housing Removed.

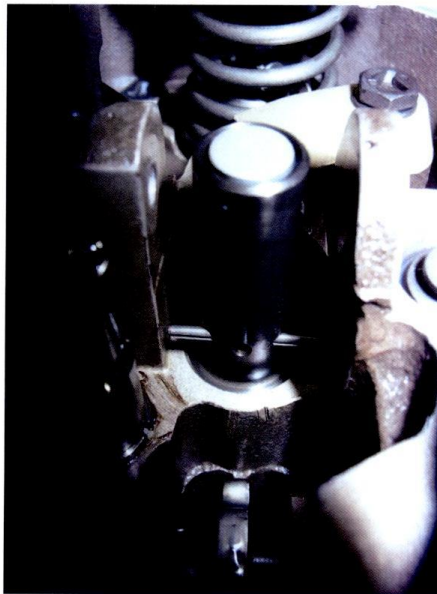
Figure 10. Governor Lock Out Valve Retention Pin.

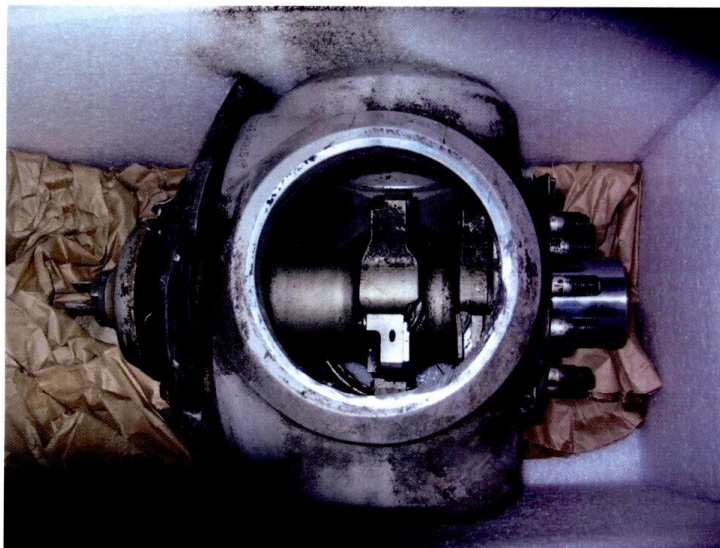
The actuator was still installed in the propeller hub (Figure 11). The spinner bulkhead was bent over and obscuring the dome of the actuator. The yoke was fully aft (Figure 12), which correlates to the feather position. There was significant damage to the yoke and wear plate area from the blade trunnion pins and bearings. The tailshaft was broken from the yoke (Figure 13, note: pitchlock screw placed in feather after position measurement to improve view).

Figure 11. Hub and Actuator Assembly as-received condition.

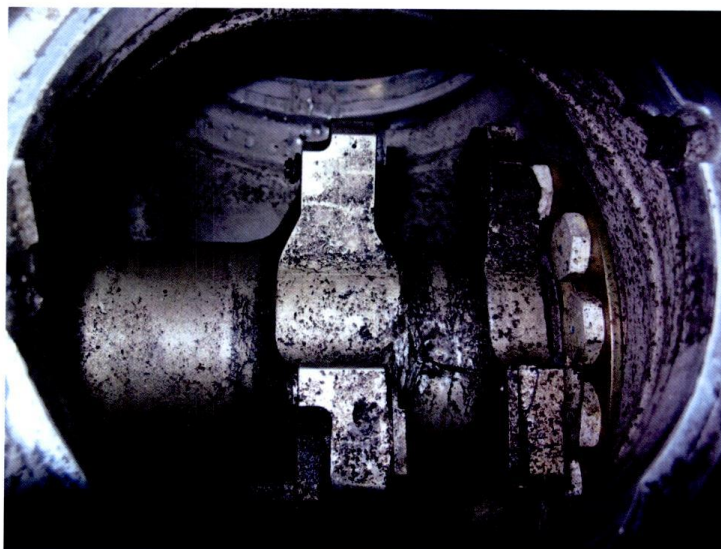
Figure 12. Actuator Yoke Position.

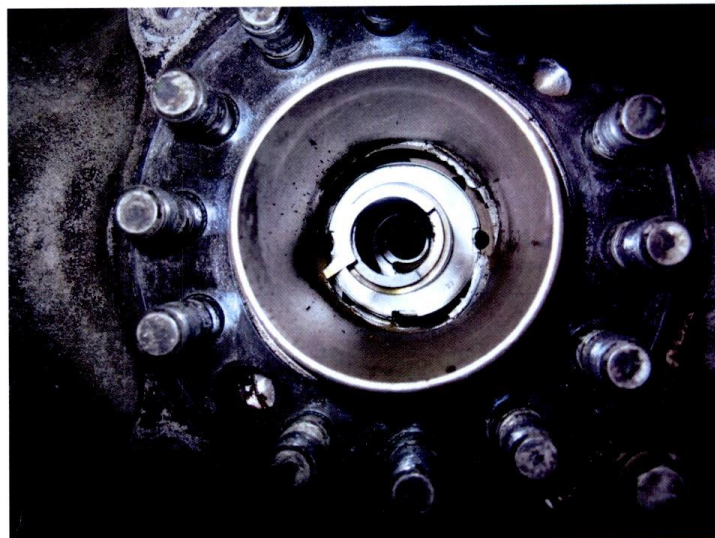
While the yoke was in feather, the Pitchlock screw was not against the feather stop (Figure 14). The Pitchlock screw was in a position of 4.0625-inches from the face of the pitch lock nut. This position does not correlate to an operational blade angle. The working limit of the Pitchlock screw in reverse is approximately 3.530-inches from the face of the pitchlock nut.

Figure 14. Pitchlock Screw Position.

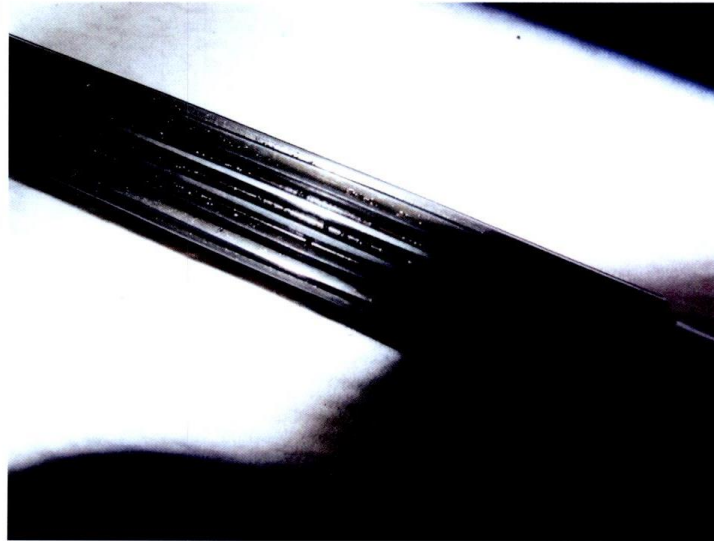
The transfer tube assembly was included with the investigation hardware, but not installed. The transfer tube and splines (Figure 15) were in good condition with the exception of the retainer. Both of the retention tabs were broken off of the retainer. In addition, the cotter pin was still installed in the retainer (Figure 16). This cotter pin must be removed to facilitate proper disassembly.

Figure 15. Transfer Tube Splines.

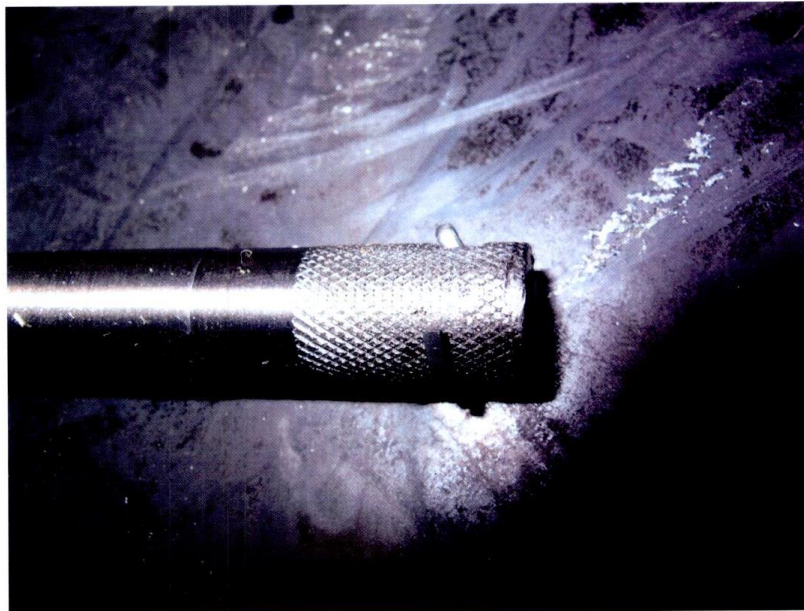
Figure 17. Transfer Tube Retainer Cotter Pin.

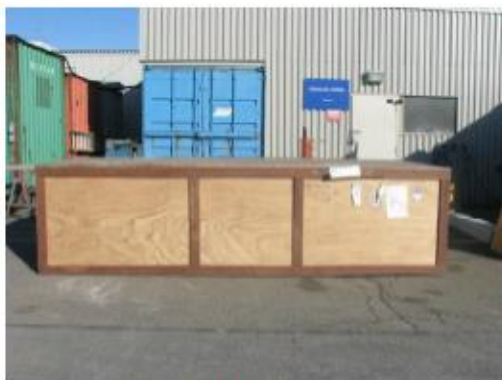
Photo no. 1

- 3.1 The large and sealed premade wooden-box as-received was opened in presence of the AIB Nigeria Authorities (photo no. 1). The wooden-box was containing the RH engine that composed of the TM S/N 115388 combined with RGB S/N 115316 was mounted to the severed battered nacelle (photo no's 2 to 8). The nacelle installation was sectioned at the facility outdoor to access and remove the engine. During sectioning of the battered nacelle installation, the exhaust tail pipe (photo no. 9) and the starter generator (photo no. 10) that are considered as airframe parts were noted missing from the engine. The impact-gouged propeller hub (or dome) without blades had remained securely bolted on the engine propeller shaft (photo no. 5) and was de-mated from the propeller shaft (photo no's 11 & 12).

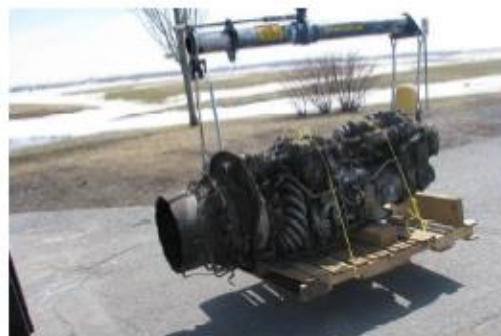
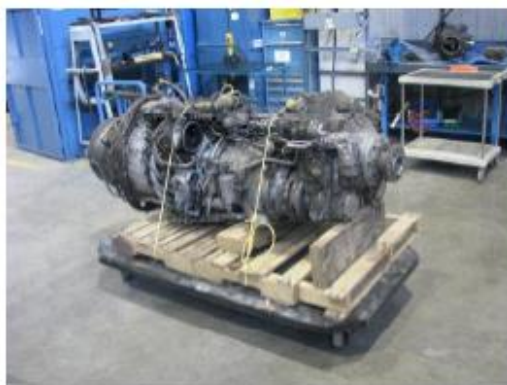
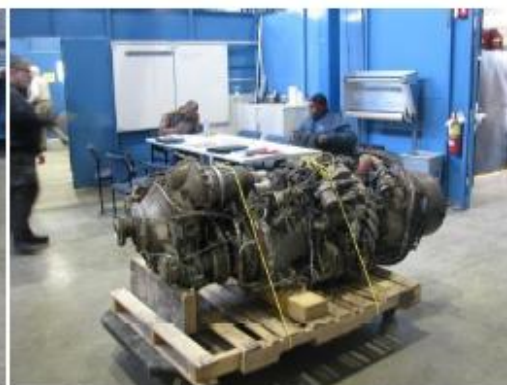
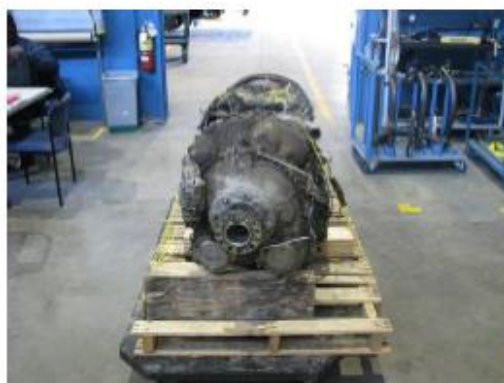
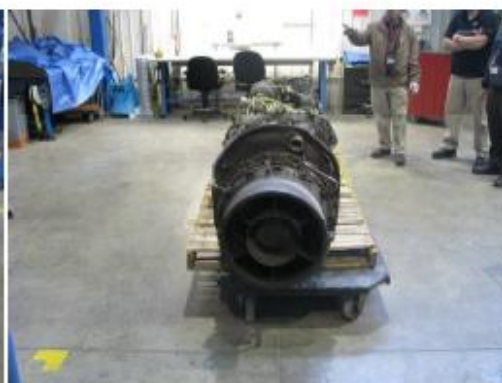
- 3.2 The RH engine with several attached airframe components (photo no's 13 to 17) was taken to the Service Investigation Quarantine Area (SIQA) for disassembly investigation.

- 4.6 There was no evidence of fire damage noted to the engine externals and casings (photo no's 14 to 17, & 33). The T6 thermocouple bus bars, fire-seals, several oil and air delivery tubes and insulation blankets were dented and bent (photo no's 37 & 38). The T6 thermocouples and harness were intact and securely in place showing no discontinuity with the bus bars. The igniter plugs and ignition harnesses and exciter box were relatively intact and in place showing an impact gouge on the LH igniter cable (photo no. 37). The fuel manifolds and flow divide/dump valve installation were intact and securely in place (photo no's 37 & 38).

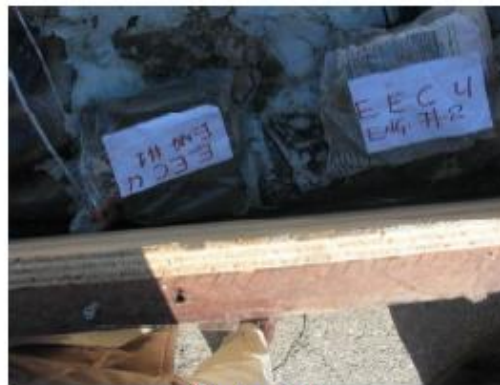
Photo no. 18

- 3.3 Two sealed plastic-bags, identified as EEC Eng #1 and EEC Eng #2, were received stored inside the large wooden-box (photo no. 18) and taken to the SIQA. Each of the bags was opened containing the RH TM S/N 115388 / RGB S/N 115316 Engine Electronic Control (EEC) S/N 87095891 and Torque Signal Conditioner (TSC) S/N RT1293 (photo no's 19 & 20), and the left hand (LH) engine S/N AA0045 EEC S/N 9090010 and TSC S/N MM4896 (photo no's 21 & 22). The torque-shaft characterization plugs were present on the TSC S/N RT1293 (photo no. 20) but the plugs were not present on the TSC S/N MM4896 (photo no. 22). All of the above accessories components were taken by P&WC Engine Controls and Accessories Air Safety Investigator for further evaluation (Refer to Section 7.0 - P&WC Engine Controls and Accessories Technical Services Evaluation (EC&ATS)).

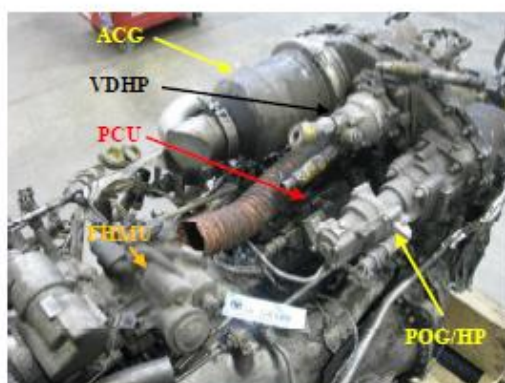
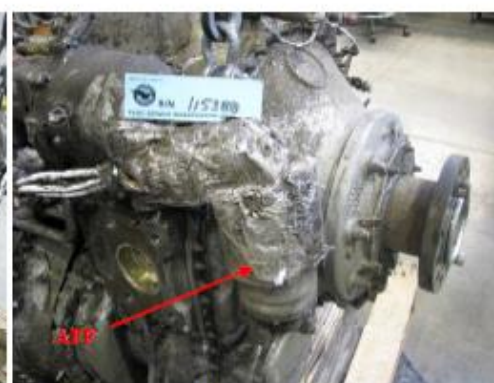
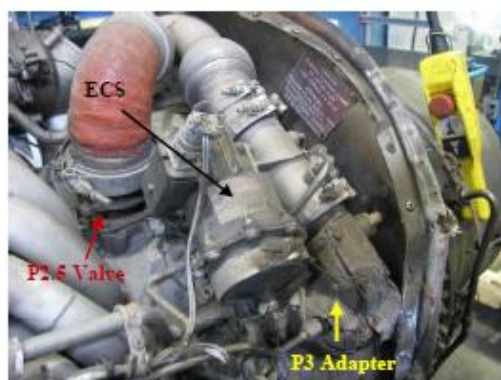
4.1 All the accessories controls considered as airframe components such as the Propeller Control Unit (PCU) S/N 871213, Auxiliary Feathering Pump (AFP) S/N 1386, Variable Delivery Hydraulic Pump (VDHP) S/N MX-467710, Alternative Current Generator (ACG) S/N 594 and the Environment Control System (ECS, or cabin air supply) tubing and control valve linking to the P2.5 check valve and P3 bleed adapter were disassembled from the engine (photo no. 23 to 25), and quarantined.

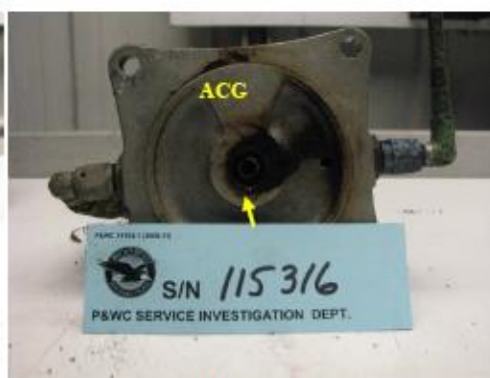
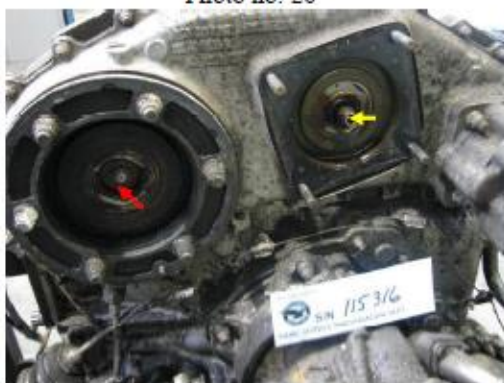
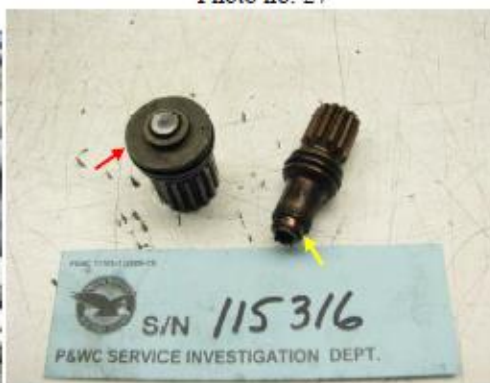
- 4.2 On removal, the VDHP and ACG drive shafts were found shear-fractured by overload at their shear neck (photo no's 26 to 29, arrows). The AFP showed impact damages with deformation and partial opening of the unit (photo no. 30). The oil strainer of the AFP was clean (photo no. 31). The other airframe accessories components showed impact gouging damages. On behalf of the AIB Nigeria Authorities request, P&WC shipped the PCU, AFP, VDHP, ACG and the Propeller Hub with the beta tube (rod) to the respective accessories controls suppliers.

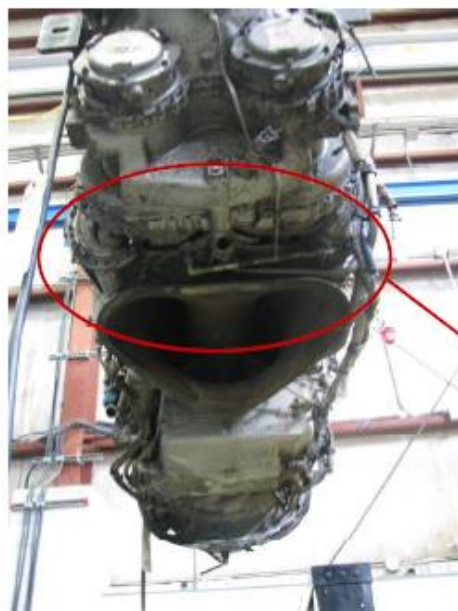
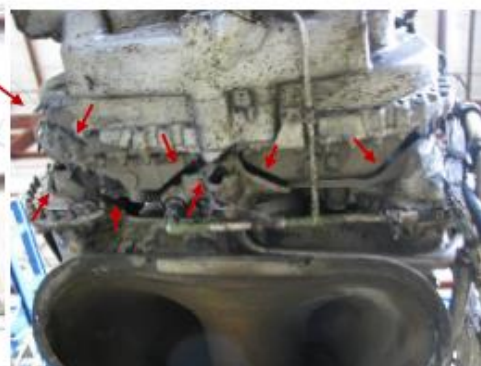
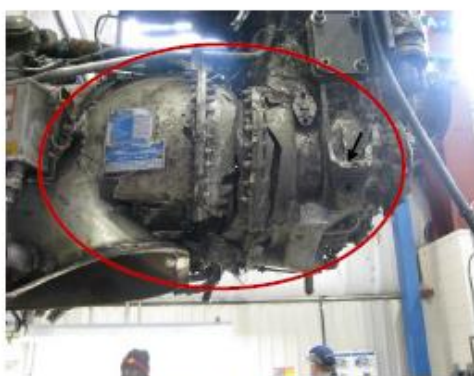
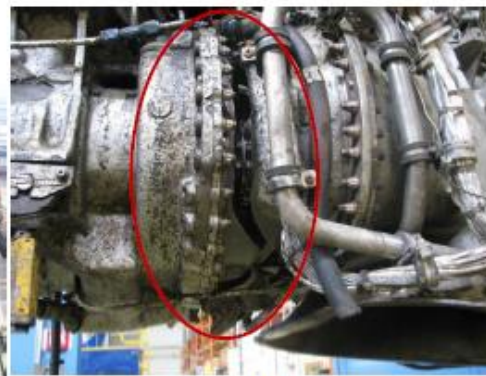
- 4.4 The input drive housing and the LH side of the rear housing of the RGB, and the front inlet case (FIC), located in the vicinity of flanges A and B displayed fracturing damages (photo no's 32 to 35) where the RGB module showed a RH offset (pilot view) in relation to the TM axial axis plane (photo no's 16 & 32). The first stage reduction input driveshaft and helical gears and bearings could be seen (being exposed) through openings at the housing fractures (photo no's 34 & 35). The RH torque mounting pad on the rear housing was fractured (photo no. 34, arrow).

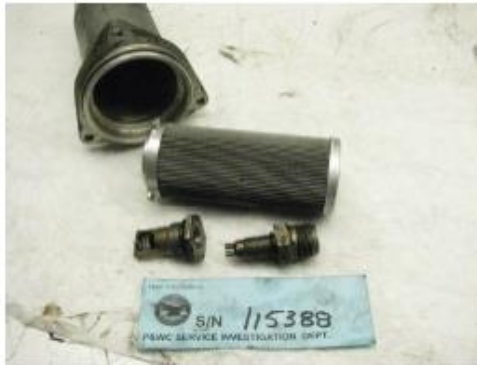
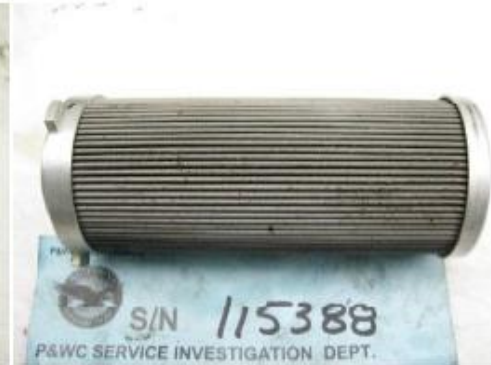
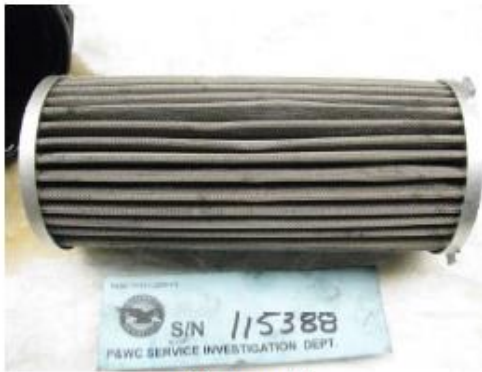
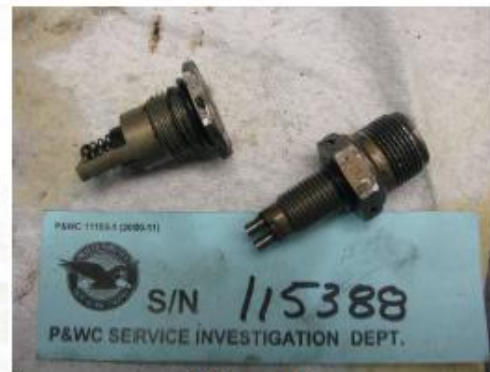
- 4.9 The RGB (scavenge, photo no's 39 & 40) and TM (main, photo no's 41 & 42) oil filters and chip detectors did not collect ferrous debris, however the scavenge oil filter and its bowl showed dirt and water droplets. The residual oil drained from the TM oil tank was contaminated with water (photo no. 43). The low-pressure (LP), high-pressure (HP) and power turbine (PT) rotor spools could be rotated freely, however there was drive discontinuity between the PT rotor spool and the RGB gear-train. There was drive continuity of the accessory gearbox (AGB) gear-train with the HP rotor spool.

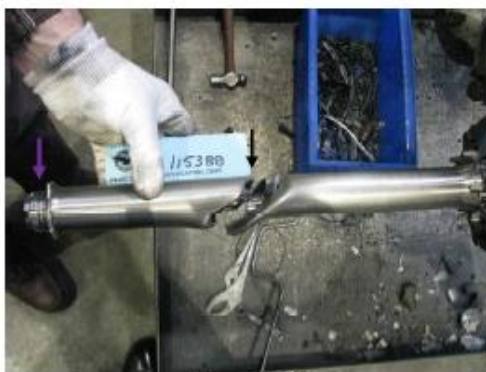
Photo no. 46

5.1 The RGB was separated from the TM at the flange 'B' requiring no retention disassembly of the balancing torque shaft assembly mated to the RGB input-shaft drive coupling in which the balancing torque shaft assembly composed of the coupling torque shaft and reference tube was found severed in torsion-overload in a 45° plane located at its mid-length (photo no's 44 to 47). A fragment of the coupling shaft assembly was noted resting inside the FIC oil compartment (photo no. 45, arrow). The teeth of the reference tube were permanently displaced in the clockwise direction and butting (or resting) solidly against the coupling torque shaft (side edge of slotted holes, photo no. 48). The 'X' marks of the reference tube in relation with the torque shaft were out of position (offset, photo no. 49). The fractured FIC was removed and showed a second torsional shear-fracture of the coupling shaft at the radius of the shaft/rear coupling (photo no's 50 & 51). The rear coupling was still retained and secured on the PT shaft by the retention bolts and nuts (photo no. 50).

Views of the fractured RGB input housing and FIC at the mating flange.

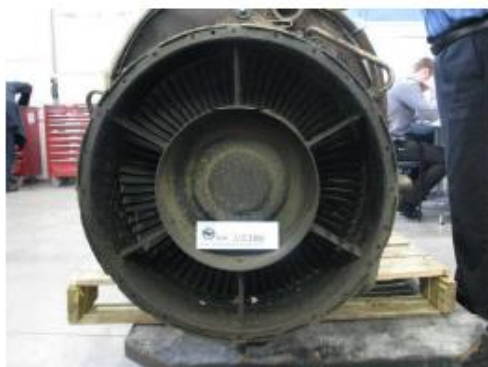
Photo no. 52 (T/E view)

- 5.2 The turbine exhaust duct (TED) was in a satisfactory condition (photo no. 52). The PT disc balancing assembly (photo no's 53 & 54) that includes the second (2nd) stage PT stator assembly of the PT rotor balancing assembly were in a satisfactory condition. Although, the TED and PT disc assembly were covered and grimed with ground sooty dirt and organic contaminants. The PT shaft (photo no. 55) with the No. 1, 2 and 7 bearings was in a satisfactory condition. A significant accumulation of ground sooty/oily dirt and organic contaminants was noted packed on the circumferential inner wall (photo no. 56, arrow) of the turbine support case (TSC) after removal of the TED and PT pack. Oil wetness and varnishing stains were also noted.

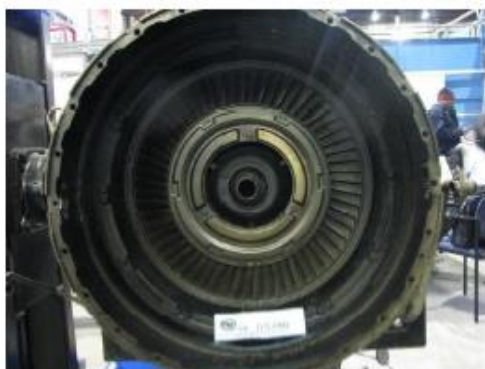
Photo no. 57

- 5.3 The first (1st) stage PT stator assembly, baffle, retaining rings and turbine inter-stage case (TIC) were in place, intact and securely retained to the LPT housing by the 26 retention bolts (photo no. 57). The No. 6 & 7 bearings housing assembly and the breather/scavenge and vent transfer tubes were in place, intact and securely retained to the TIC by the 20 retention bolts. The PT1 stator vanes and TIC were intact but grimed with ground sooty dirt and organic contaminants with oil varnishing stains (photo no. 58). The T6 thermocouples and oil transfer tubes were intact and in a satisfactory condition (photo no's 59 & 60).

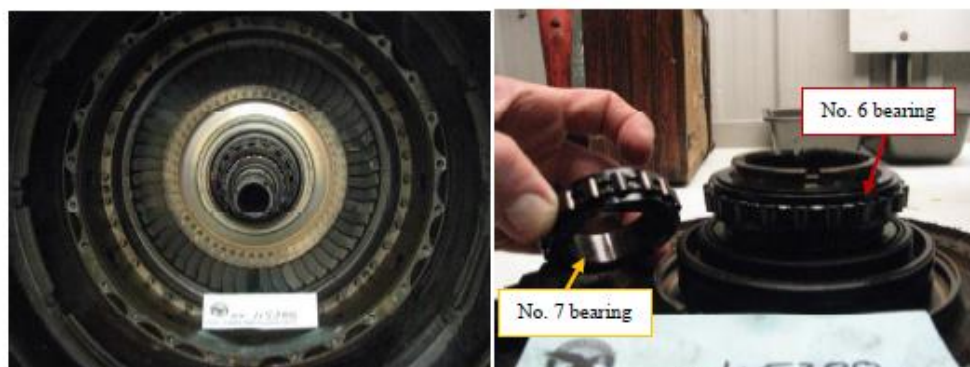
Photo no. 63 (LPT, T/E view)

- 5.5 The LPT disc assembly, the No. 3 and 6 bearings, the LP shaft of the LP rotor balancing assembly were noted to be in a satisfactory condition (photo no's 63 to 67). The LPT disc assembly was splattered with ground sooty/oily dirt and organic contaminants, and varnished and stained with oil (photo no's 65 & 66). The LP centrifugal impeller being part of the LP rotor balancing assembly showed nicking, gouging and curling damages to the vane leading edges (L/E) from impacts (photo no's 69 to 74). The LP impeller was also grimed and contaminated with ground sooty dirt and organic debris, and a large brick-red tile was found lodged between two vanes (photo no. 74, arrow). The air gas-path wall of the LP diffuser case (Apexes & P2.5/P3 air cavity side, photo no's 67 & 68) and exit ducts were contaminated and splattered with dirt. The LP stator vane-ring (photo no. 75) and shroud segments (photo no. 76) were intact but grimed with dirt.

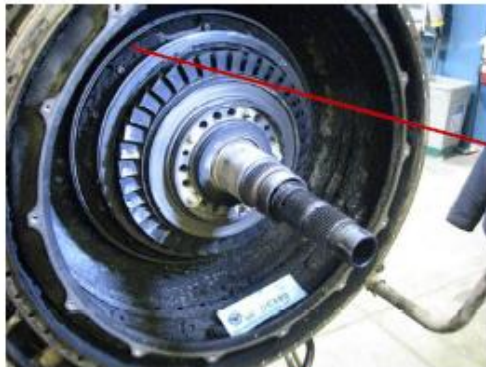
Photo no. 82

- 5.7 The HPT disc assembly (photo no's 82, 98 & 99) and centrifugal impeller (photo no's 100 to 103) with the No. 4 and 5 bearings (photo no's 102 & 103) of the HP rotor balancing assembly were in a satisfactory condition however the L/E of the HP impeller vanes showed various extents of impact nicking and gouging damage. The HP impeller and HPT disc assembly were covered and grimed with ground sooty dirt and organic contaminants, and oil wetness and varnishing stains noted. The upstream wall of the GGC and HP impeller housing forming the P2.5 & P3 air pressure cavity was contaminated and splattered with dirt and organic contaminants (photo no. 100).

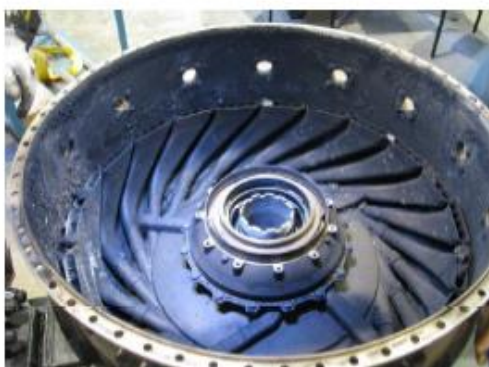
Photo no. 92

- 5.6 De-mated separation of the turbine support case (TSC) from the gas generator case (GGC) at the flange 'K' showed a significant accumulation of ground sooty/oily dirt and organic debris that contaminated, packed and clogged the P3 air cavity (vessel) and pressurizing/cooling-passages formed by the TSC, GGC, the combustion chamber liners and HP stator assembly (photo no's 77 to 93). The internal of the combustion chamber formed by the inner and outer liners was heavily contaminated and covered with ground sooty/oily dirt and organic debris (photo no's 82 & 88). Dark oily varnishing stains were also noted to the aforementioned parts. The P3 air passages and nozzle tips of all the fuel manifolds (FN's) were partially to totally covered and clogged with ground sooty dirt and organic debris in which some growth of fungus formation noted (photo no's 86, 87, 94 to 97). The GGC apexes and diffuser ducts (photo no's 92 & 93) showed impact nicks and foreign dirt/organic contaminants.

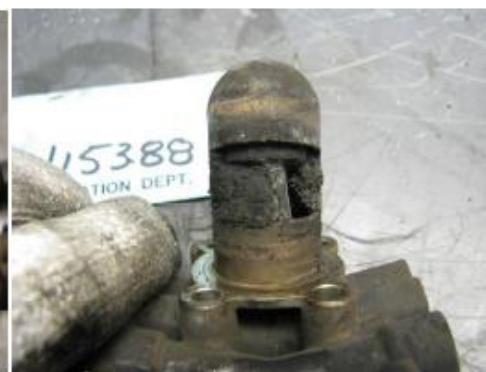
Photo no. 94 (Nozzle tip)

Randomly fuel manifold, as representative

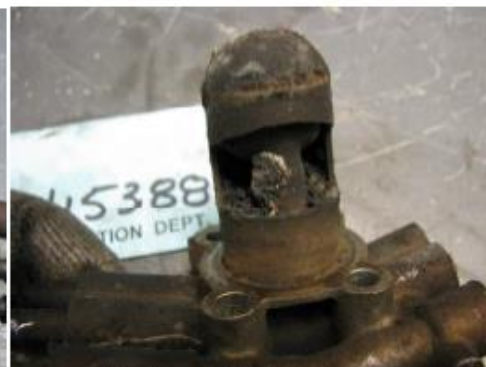
Photo no. 96 (Nozzle tip)

Another randomly fuel manifold, as representative

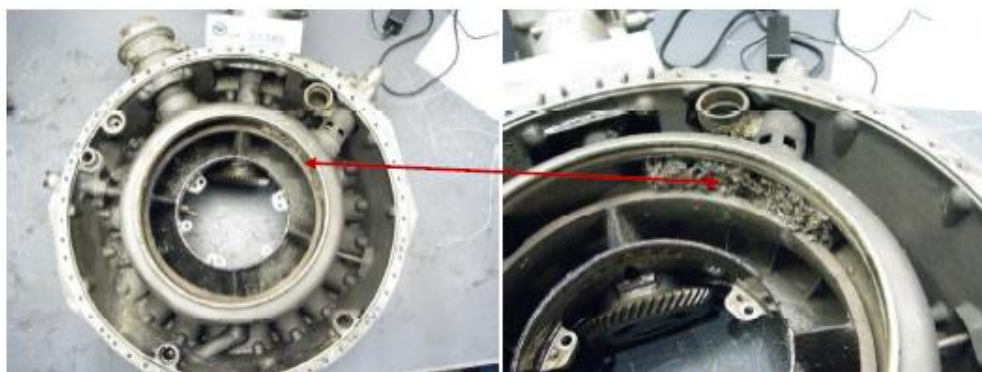
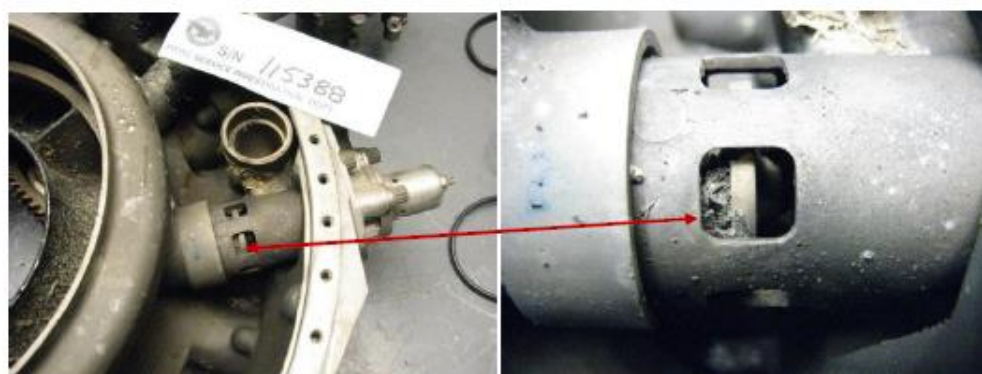
- 5.8 The inter-compressor case (ICC) showed that the case upstream/downstream walls forming the P2.5 & P3 air pressure cavity were contaminated and splattered with dirt and organic contaminants (photo no. 104). In addition, a large amount of ground dirt and organic debris was collected and clogging the ICC P2.5 plenum (photo no's 104 & 105) and the inner housing of the P2.5/P3 air pressure valve assembly by keeping (jamming) the switching valve in the halfway open position (photo no's 106 & 107).

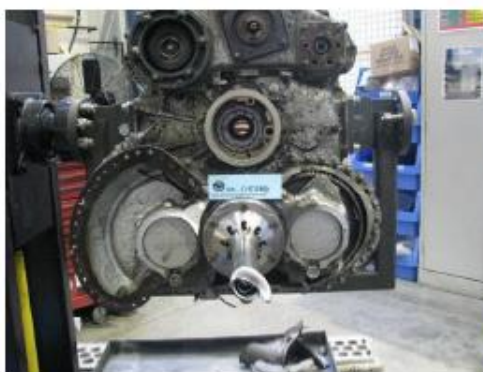
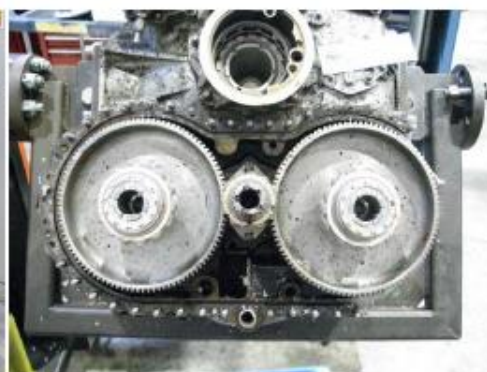
- 6.1 The input-drive housing of the RGB housing set was fractured in large multiple fragments. The oil spray-nozzle transfer tubes of the 1st stage reduction gears and bearings (No. 8 to 12) were fractured. After removal of the housing fragments, the RGB gear-train could be rotated freely. Water, dirt and few brick-red tile fragments were contaminating the oil compartment of the 1st stage reduction gear-train. The lay-shafts and couplings, and the helical gears, input shaft and bearings composing the 1st stage reduction gear-train of the RGB were intact but the gears and bearings were dry and displayed stationary surface corrosion characterised by the rusty-orange and dark oxide discolorations. Refer to photo no's 108 to 124.

Downstream views of the fractured 1st stage reduction input-drive housing, and the installation of the 1st stage reduction gear-train.

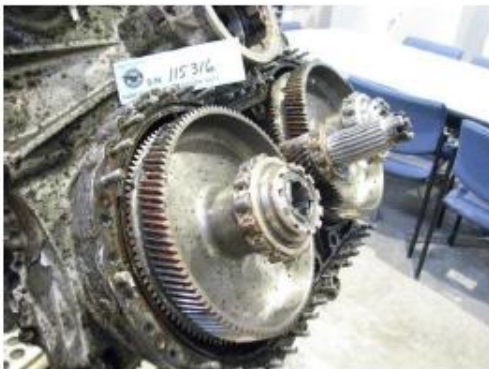
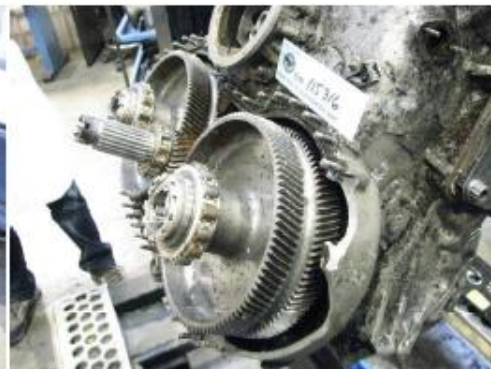
Alternate views of the condition of the 1st stage reduction gear-train, and the fractured RGB rear housing on the RH side.

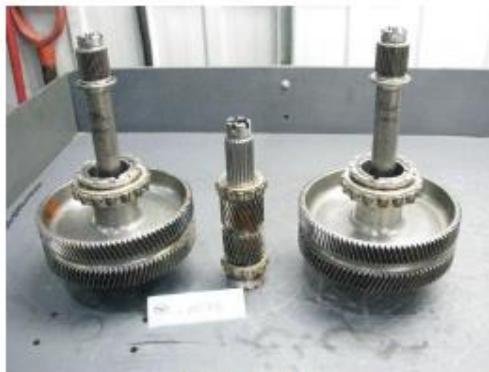
Photo no. 117

Views of the 1st stage reduction gear-train, and the input drive shaft and coupling.

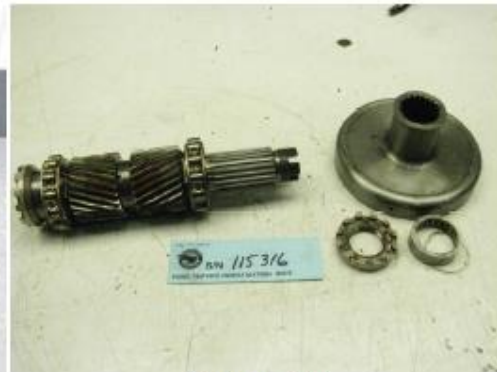
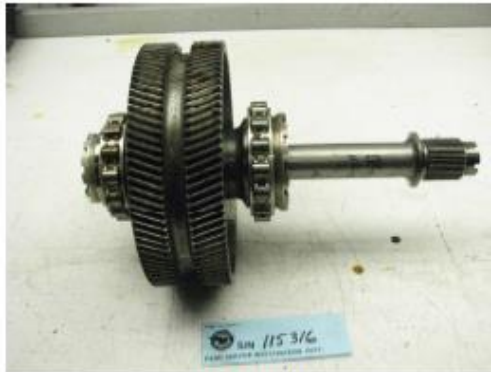
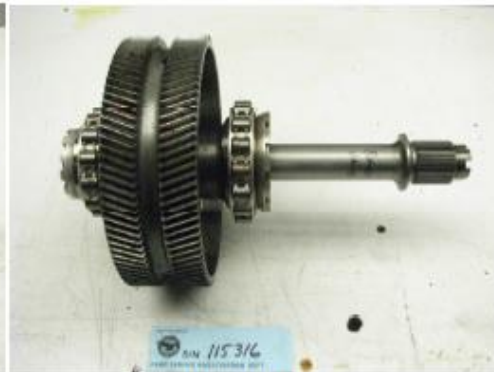
Views of the LH and RH 1st stage reduction helical gears /lay shafts/bearings assemblies.
